CPSC Staff Assessment on Eutectic-Type Thermal-Cutoff Fuse Failures in Shaded-Pole Motors Used in Exhaust Fans

December 2017

Arthur Lee
U.S. Consumer Product Safety Commission
Directorate for Engineering Sciences
Division of Electrical Engineering and Fire Sciences
5 Research Place
Rockville, MD 20850

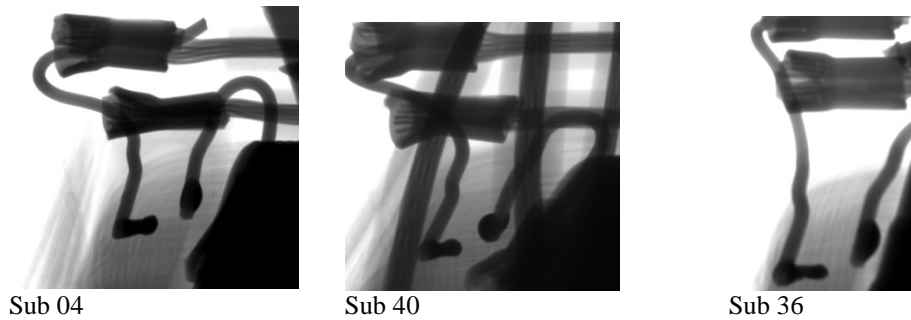
Figure 15. Radiographs of TCOs after lock-rotor testing with consistent shape

In other testing, where the TCO opened during lock-rotor conditions around the same elapsed time of 20 minutes, the thermal linkage had the same characteristic of only one end of the thermal linkage melting, as shown in Figure 15. This appeared to be caused by the TCO wire lead that is connected to the winding having a higher temperature than the wire lead connected to the power conductor. The wire lead would conduct the thermal energy from the winding during locked-rotor operation, thus causing one TCO wire lead to heat faster than the other TCO wire lead. Staff observed that for cases when the elapsed

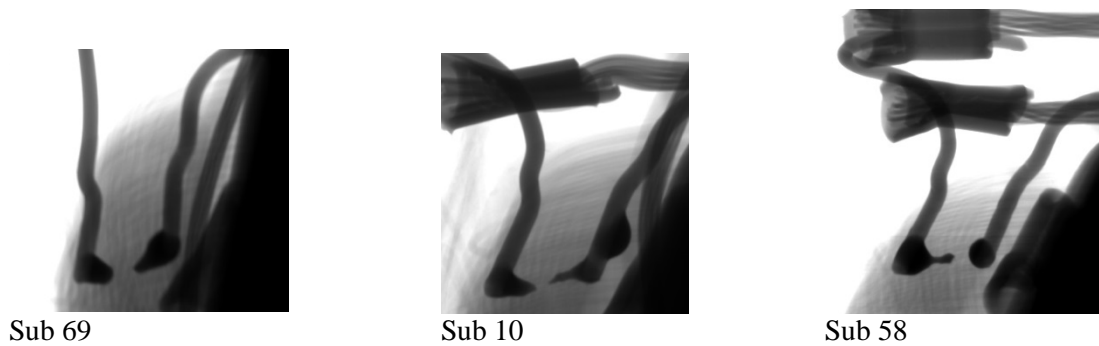
Figure 16. Radiographs of TCOs after lock-rotor testing with unusual shapes

time was longer during the lock-rotor condition for the TCO to trip, and the temperature was higher than average, the thermal linkage would have inconsistent melting patterns, as shown in Figure 16. Staff expected that the delayed opening would result in a uniform temperature gradient within the TCO, thus causing the fusible linkage to melt completely or uniformly. But this was not the case, because the thermal linkage had irregularities, which suggests that other factors may be affecting the melting characteristics of the linkage.

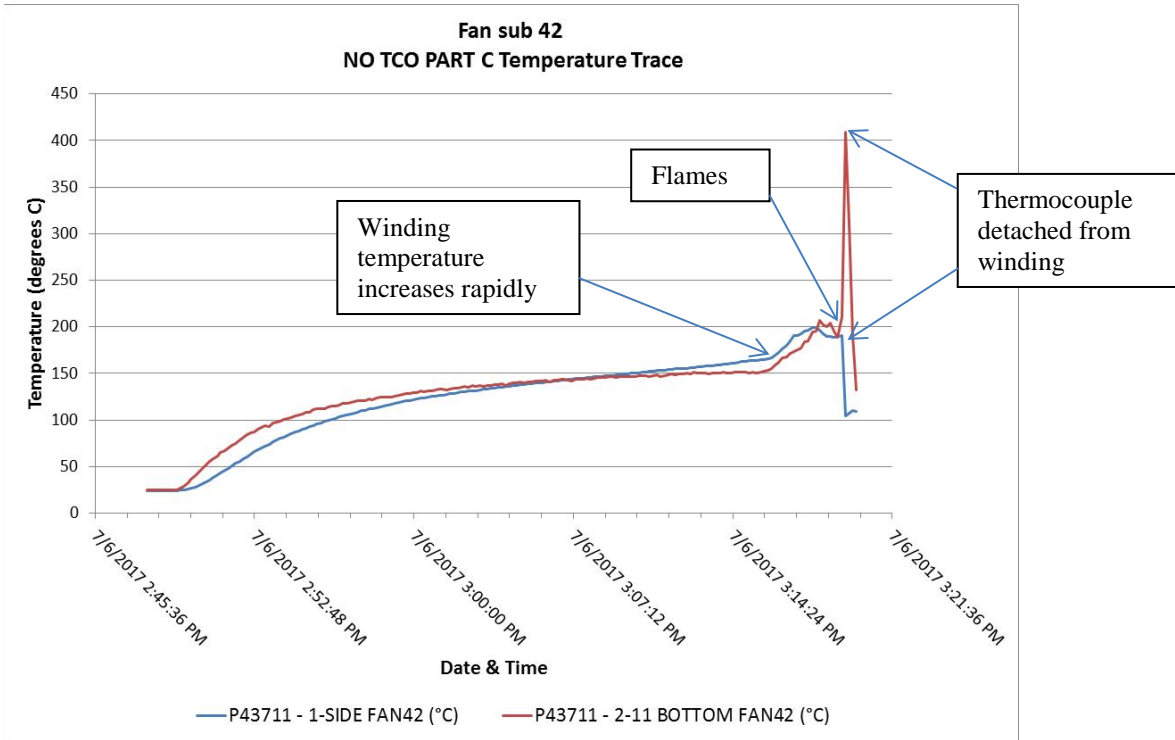
Figure 18. Sub 42 third test period Lock-Rotor Test with no TCO

For the third test period, the fan was energized in the lock-rotor condition, and after about 30 minutes, the temperature increased rapidly, which resulted in smoke and flames. The thermocouple temperature traces are shown in Figure 18. The motor winding ignited, which then ignited the plastic impeller, as shown in Figure 19. The plastic impeller resulted in dripping, flaming plastic. The total lock-rotor test time was about 4.5 hours (period 1 + period 2 + period 3).

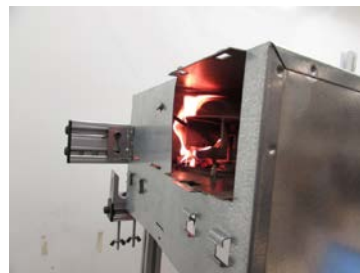
More of the winding wrap and the coating on the winding burns, thus creating a larger flame
