## Death in the line of duty...

A summary of a NIOSH fire fighter fatality investigation

December 16, 2005

### Career Fire Captain Dies When Trapped by Partial Roof Collapse in a Vacant House Fire - Texas

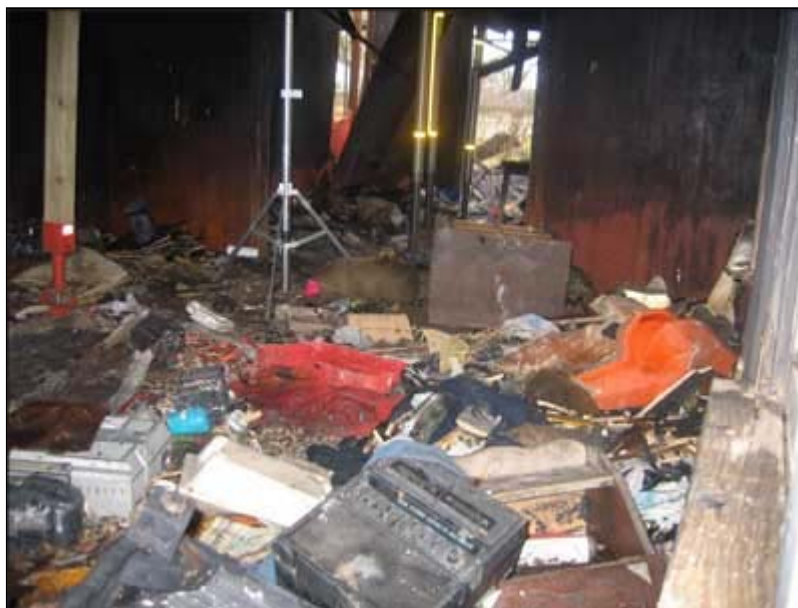
In this incident, the structure had been abandoned since the time of the owner's death in 2004. The structure was known to be used by vagrants for illicit activities. The structure had also been ransacked resulting in broken furniture, household goods, debris, and litter cluttering the floors.

**Photo 1. Note cluttered condition of floor in living room.**

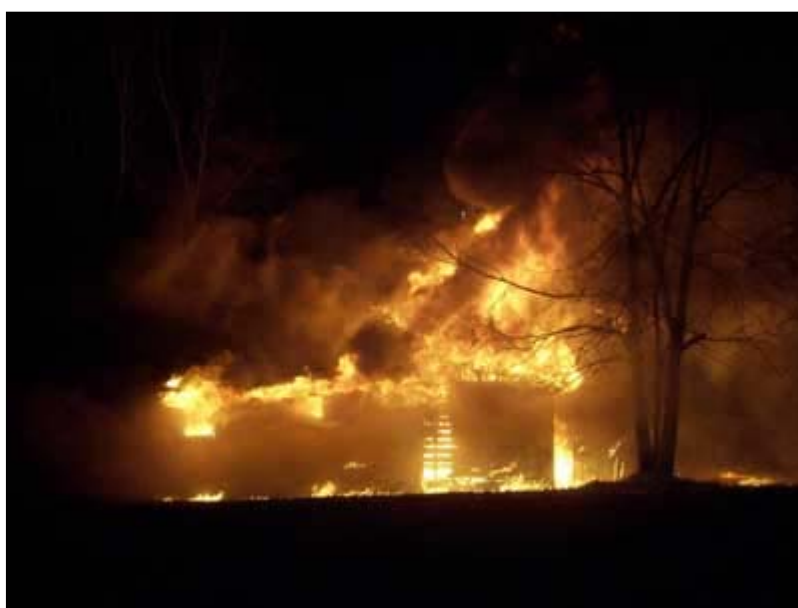
The DC46 and the Captain of L46 walked around to the C / D corner of the structure to observe conditions (see [Figure 1](#)). DC46 told the L46 Captain that roof ventilation was not possible. DC46 directed L46 to do interior search. The L46 Captain told his crew to take the front door off of its hinges because the door was partially obstructing access into the house. The L46 Captain entered by himself. After removing the door and setting it to the right of the entranceway, the L46 crew (2 fire fighters) entered the structure and started a left-hand search through the living room and front bedroom, keeping in contact with the interior walls. The Captain and the L46 crew members never met inside the structure. L46 was equipped with a thermal imaging camera (TIC) but it was not used during the initial search operations. *NOTE: Several fire fighters reported to NIOSH investigators that flames were venting through the roof at the rear of the structure when they arrived on-scene. Some reported that flames could be seen well above the roof line (see [Photo 2](#) taken shortly after crews began arriving on-scene).*

**Photo 2. Taken just prior to, or near the time, of the collapse.  
See Photo 3 for the same view after fire extinguishment.**

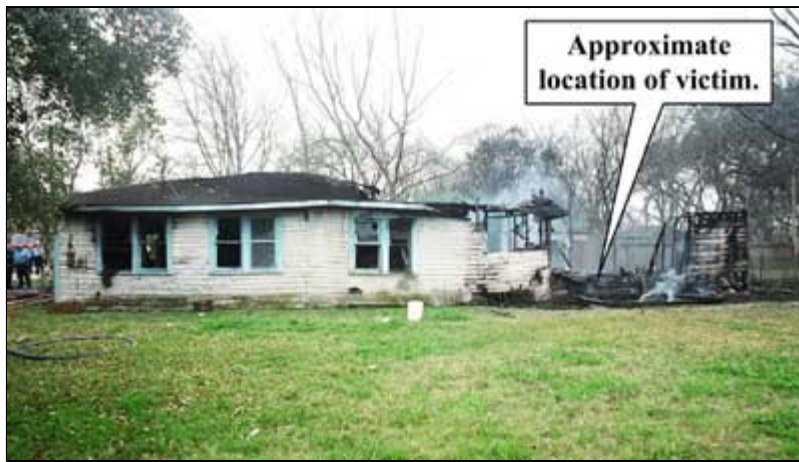
The roof collapse occurred over the den addition at the rear of the structure (see [Photo 3, 4](#) and [Figure 1](#)). The E46 crew was operating in the kitchen area and had just located the fire and begun to direct water onto the flames. The E46 captain (the victim) had just taken the nozzle from the nozzleman to direct water toward the rear of the house. The two E46 fire fighters were just reaching to pull more slack when they were knocked down by the force of the collapse. The L46 Captain who was in the dining room behind the two E46 fire fighters reported hearing a rumbling sound just prior to the collapse. The L46 Captain immediately began yelling for everyone to get out. The L46 Captain radioed that fire fighters were trapped, and requested help. Then, while trying to adjust his radio, he dropped it and was not able to retrieve it (see [Figure 1](#)). The nozzleman from E46 was disoriented by the collapse but began moving toward the front of the house. At some point, he noticed flashing lights from the apparatus parked on the street and dove headfirst out a living room window on the D-side. The other E46 fire fighter was able to follow the hoseline to the front door. Just prior to the roof collapse, the E55 crew had advanced the second 1¾-inch hoseline to the kitchen near where E46 was operating. They could hear the L46 Captain talking nearby. The E55 crew also were knocked down by the force of the collapse, but were able to follow their hose line toward the front of the house and were assisted to the outside.

**Photo 3. Note roof collapse area at rear of house.**  
*Photo courtesy of fire department.*

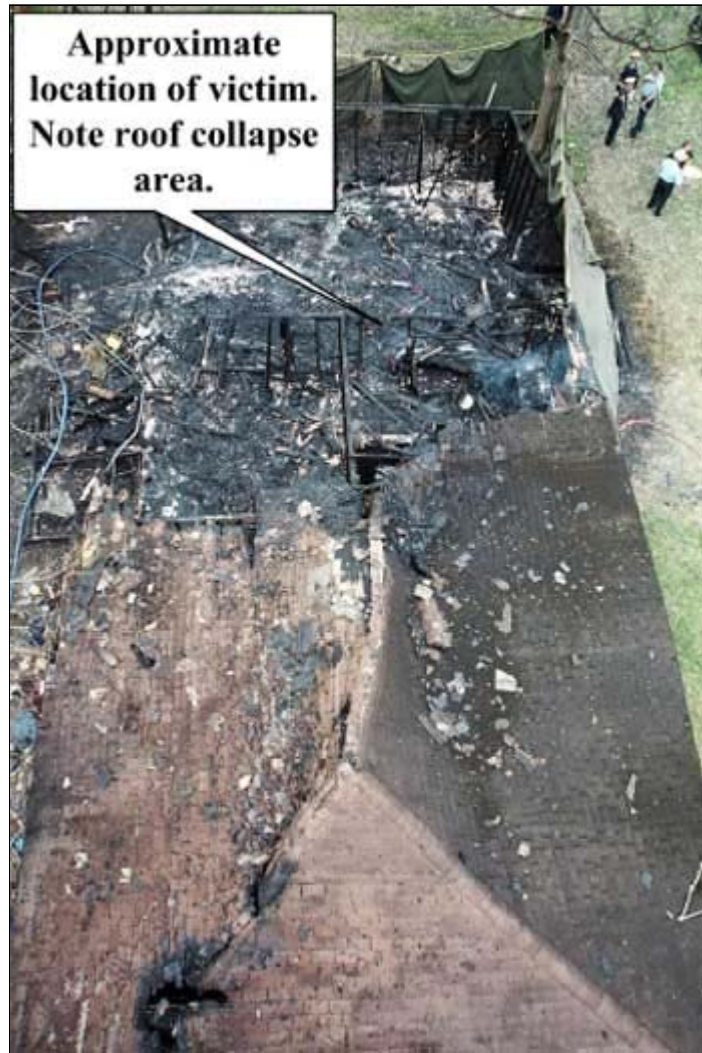
**Photo 4. Aerial view of collapse zone.**  
*Photo courtesy of fire department.*

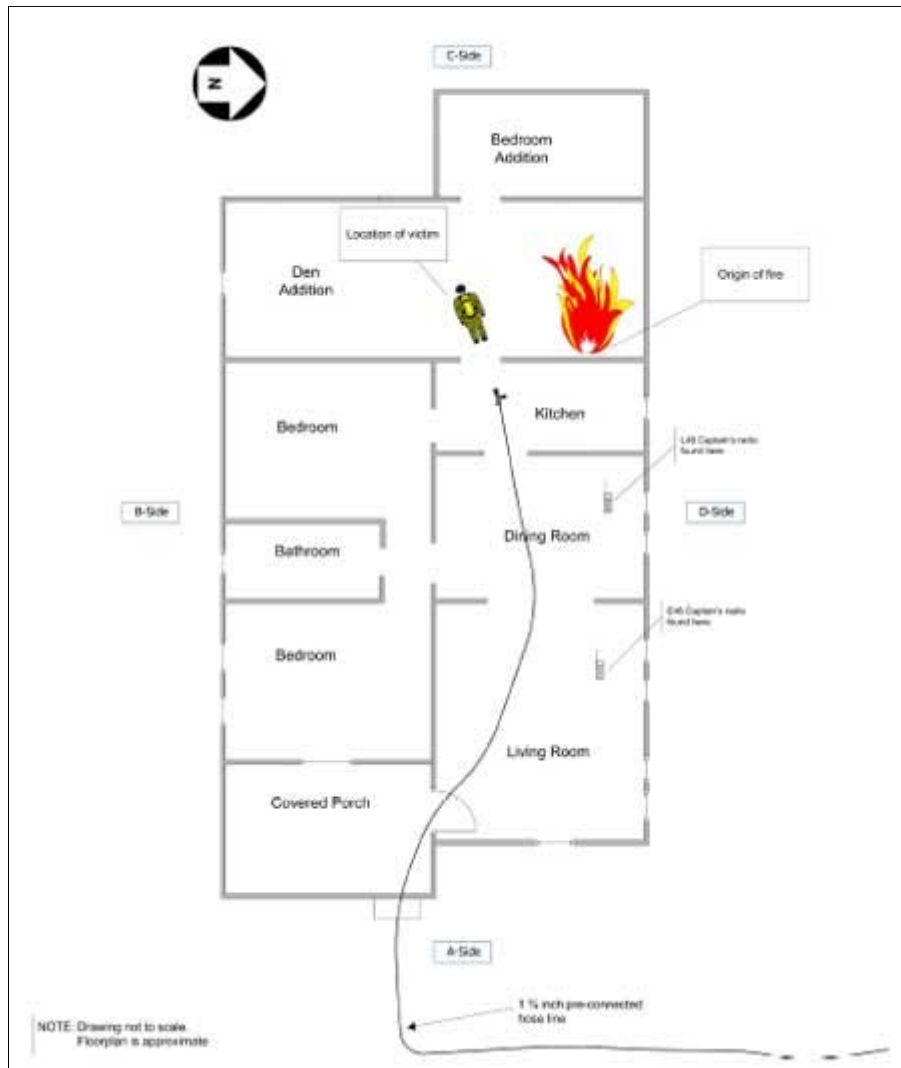
Figure 1. Layout of structure.

At approximately 0629, the E25 crew located the victim face-down under approximately 2 – 3 feet of debris and rubble from the collapsed roof. The victim was found facing the rear of the structure (see [Figure 1](#)). The victim's SCBA cylinder was the only thing showing above the debris. The victim's PASS device was not in alarm mode (no audible alarm and no flashing lights were detected) when the rescuers found the victim. The victim was pronounced dead on the scene by medical examiners. The victim's turnout gear and SCBA were severely damaged by heat and/or flame exposure at the time the victim was located. The SCBA was too badly damaged to be tested by NIOSH for proper performance.
