## Six Career Fire Fighters Killed in Cold-Storage and Warehouse Building Fire - Massachusetts

### SUMMARY

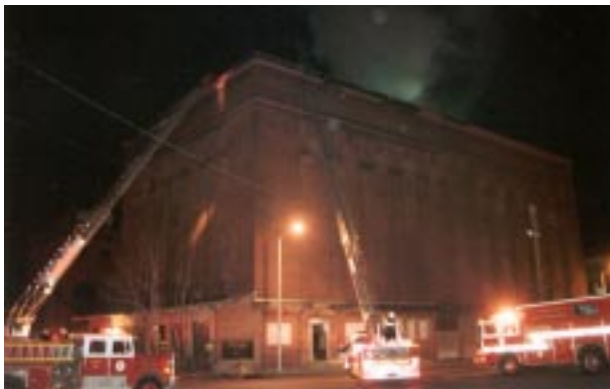
*Cold Storage and Warehouse Building Shortly After First Alarm - 1825 Hours*

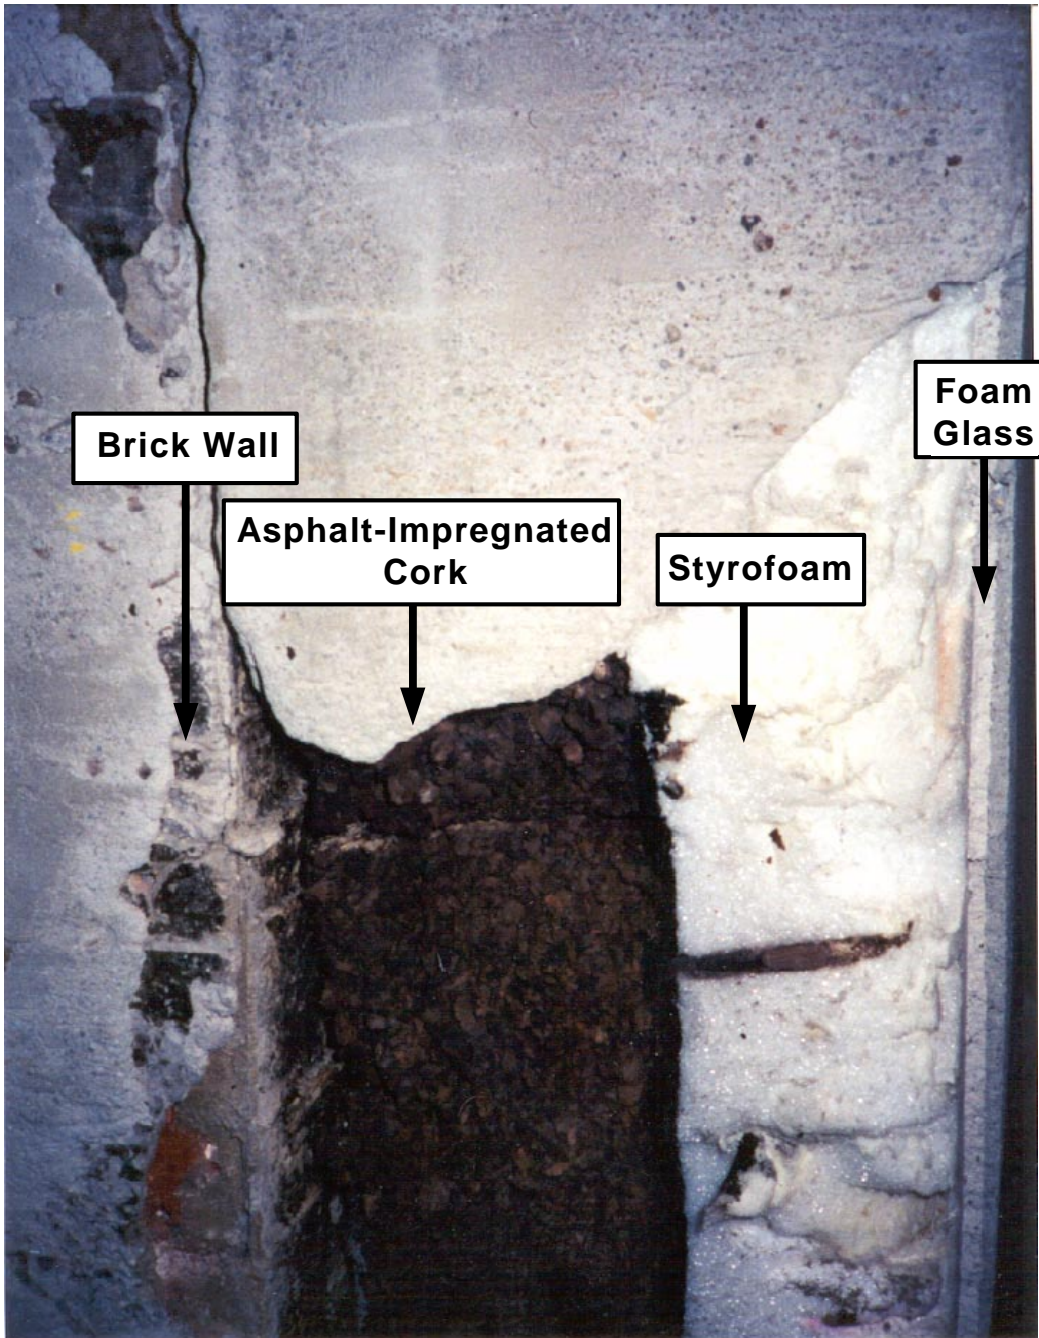
*Photo 1. Interior Insulation of Cold-Storage and Warehouse Building*

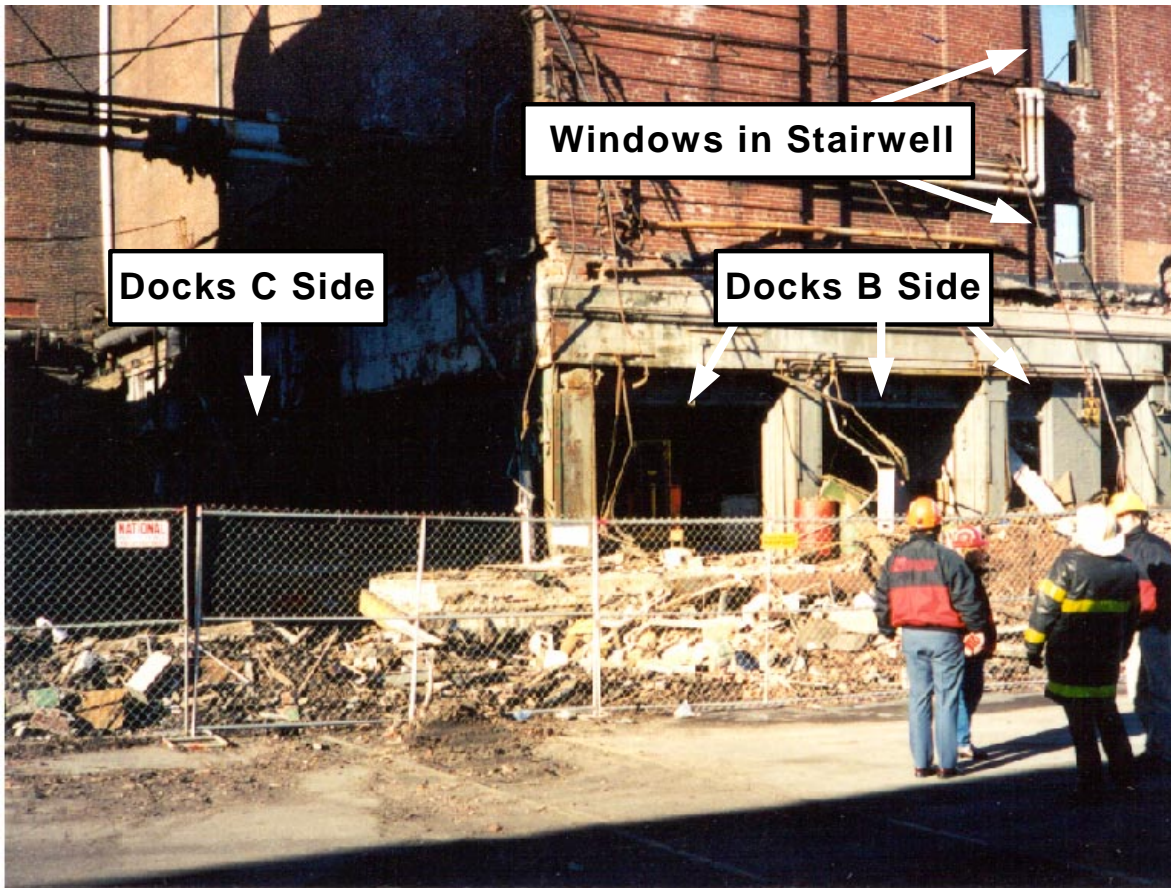
*Photo 2. Corner "B/C" of Cold-Storage and Warehouse Building*

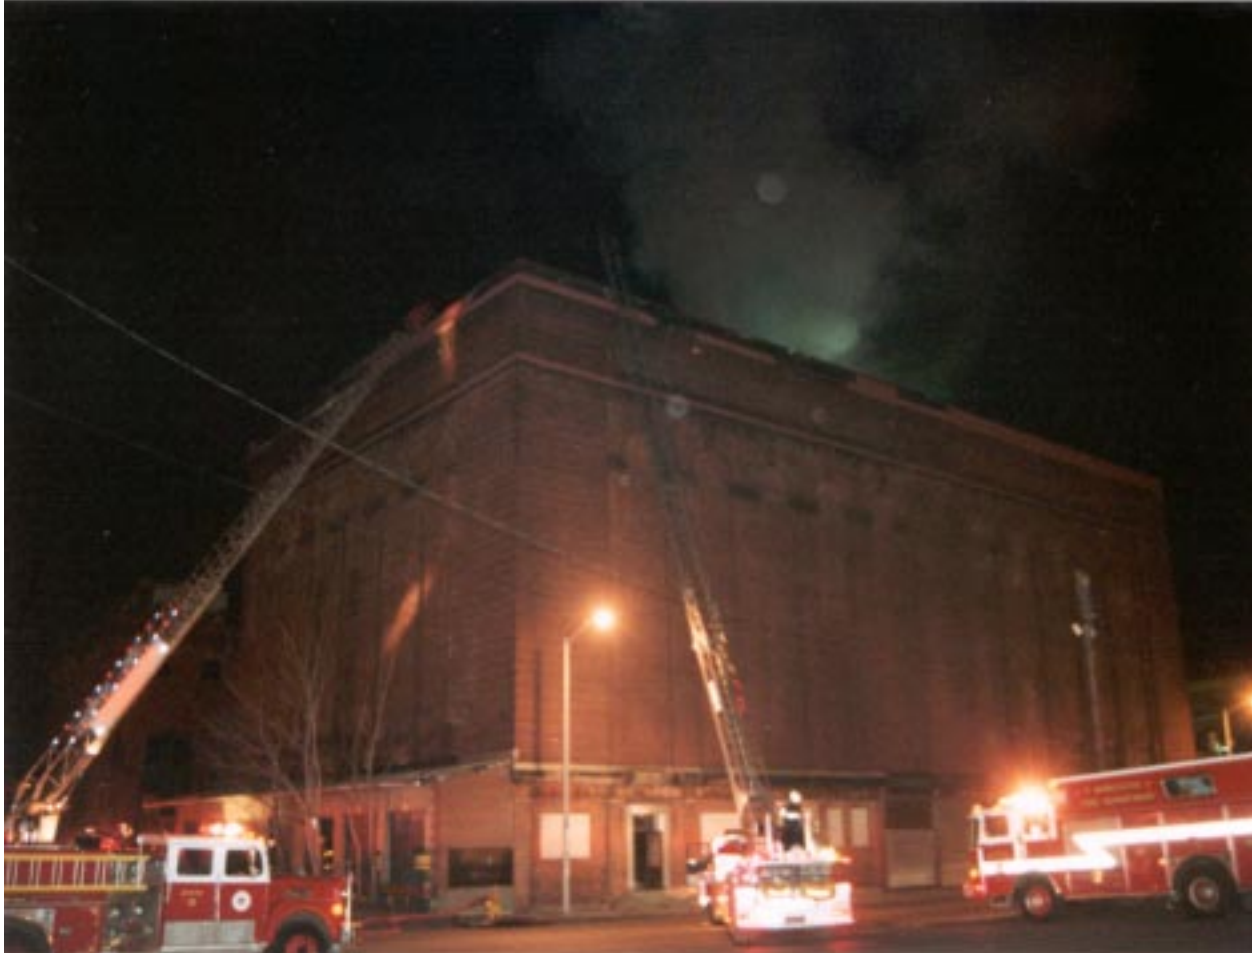
*Photo 4. Cold-Storage and Warehouse Building Shortly After First Alarm - 1825 Hours*

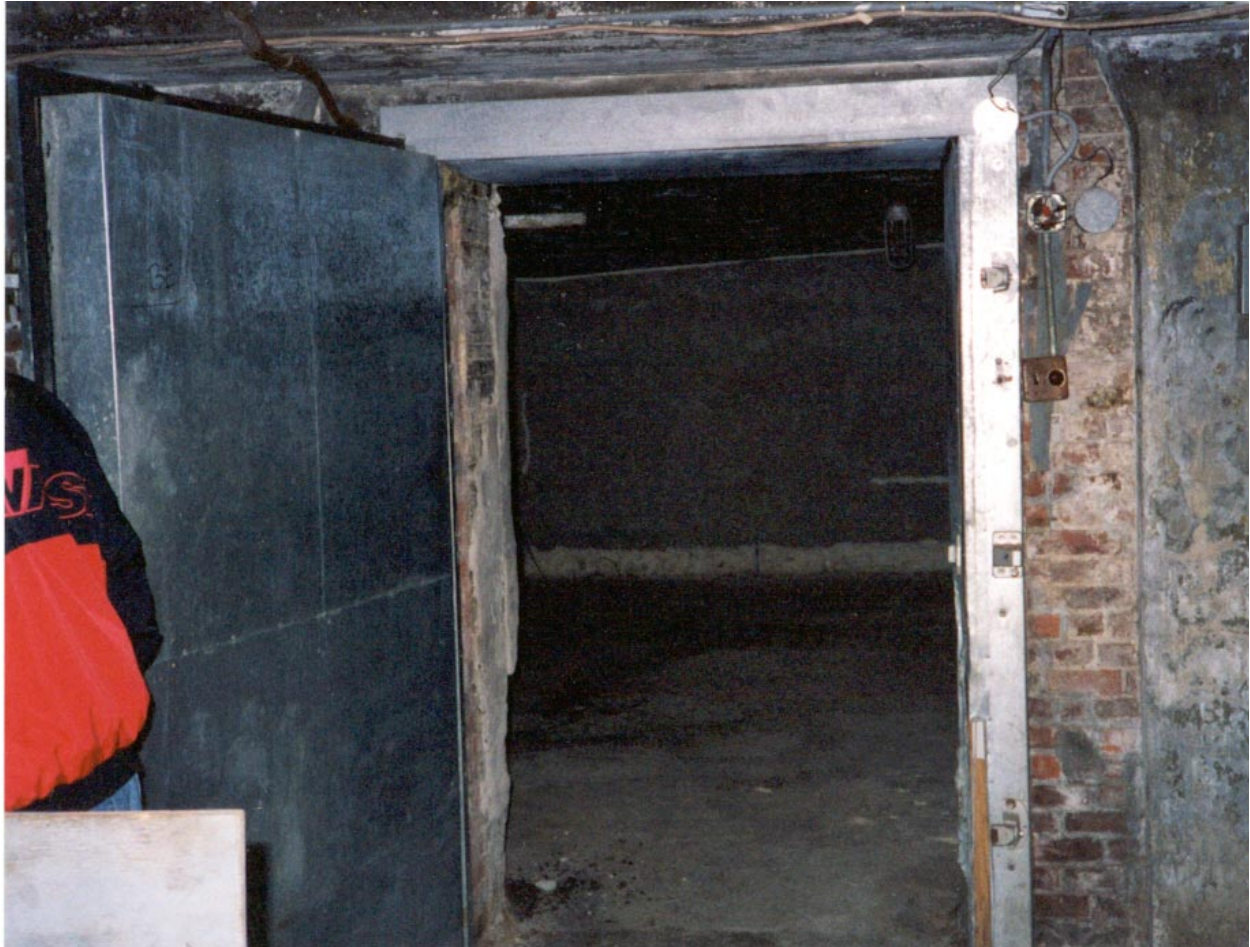
*Photo 5. Cold-Storage Freezer Room*

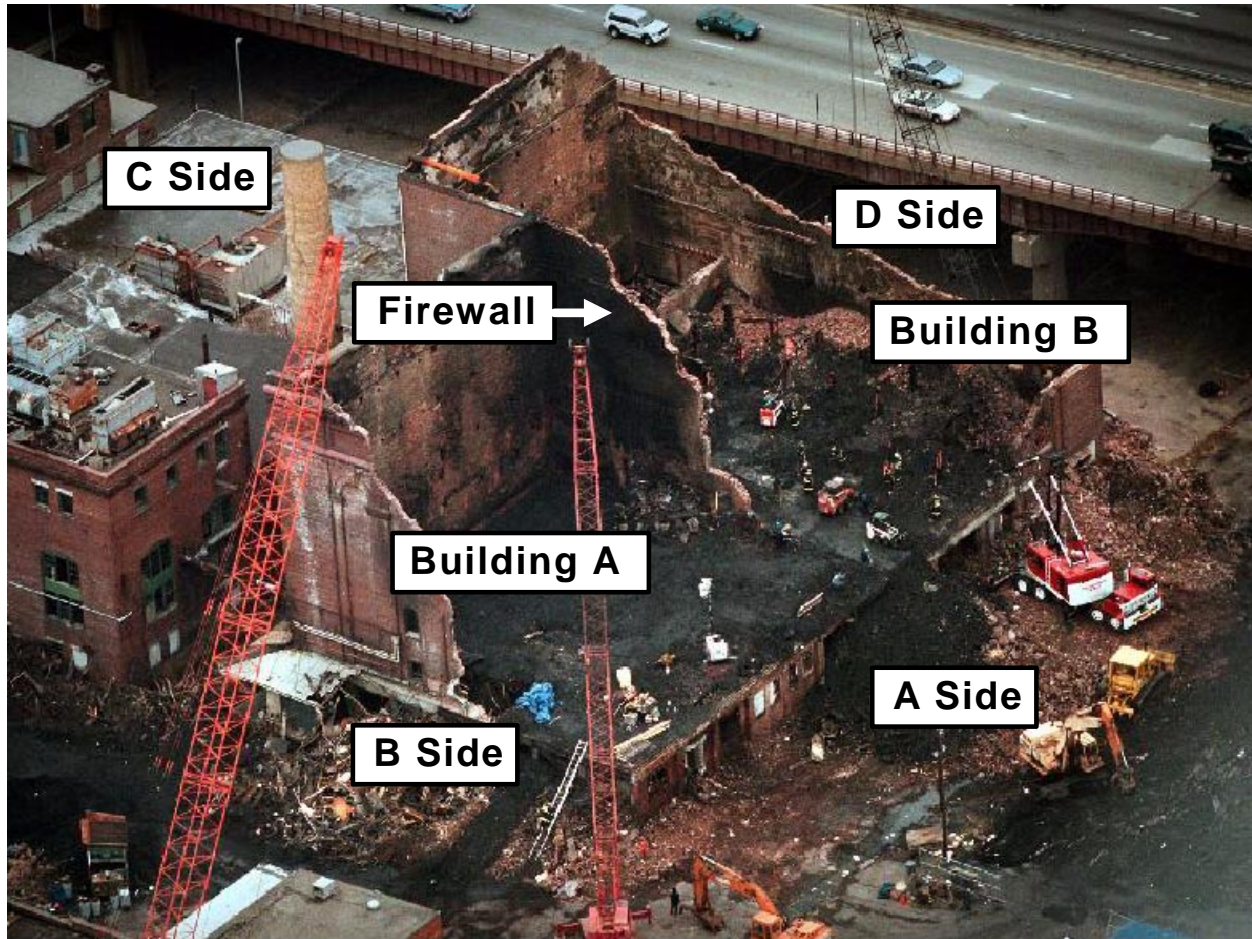
*Photo 6. Firewall Between Building A and B, Cold-Storage and Warehouse Building*

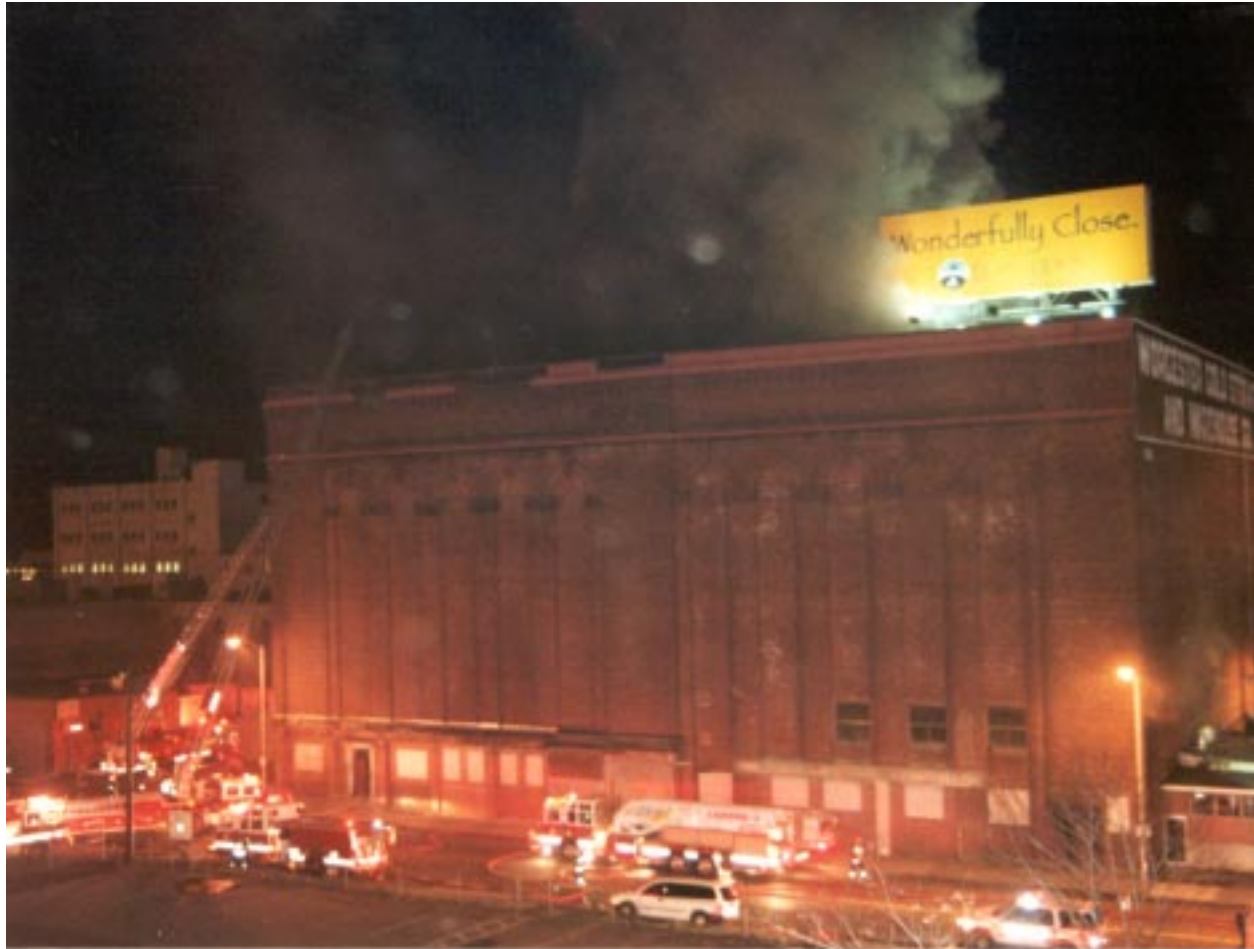
*Photo 7. Cold-Storage and Warehouse Building After Third Alarm - 1842 Hours*

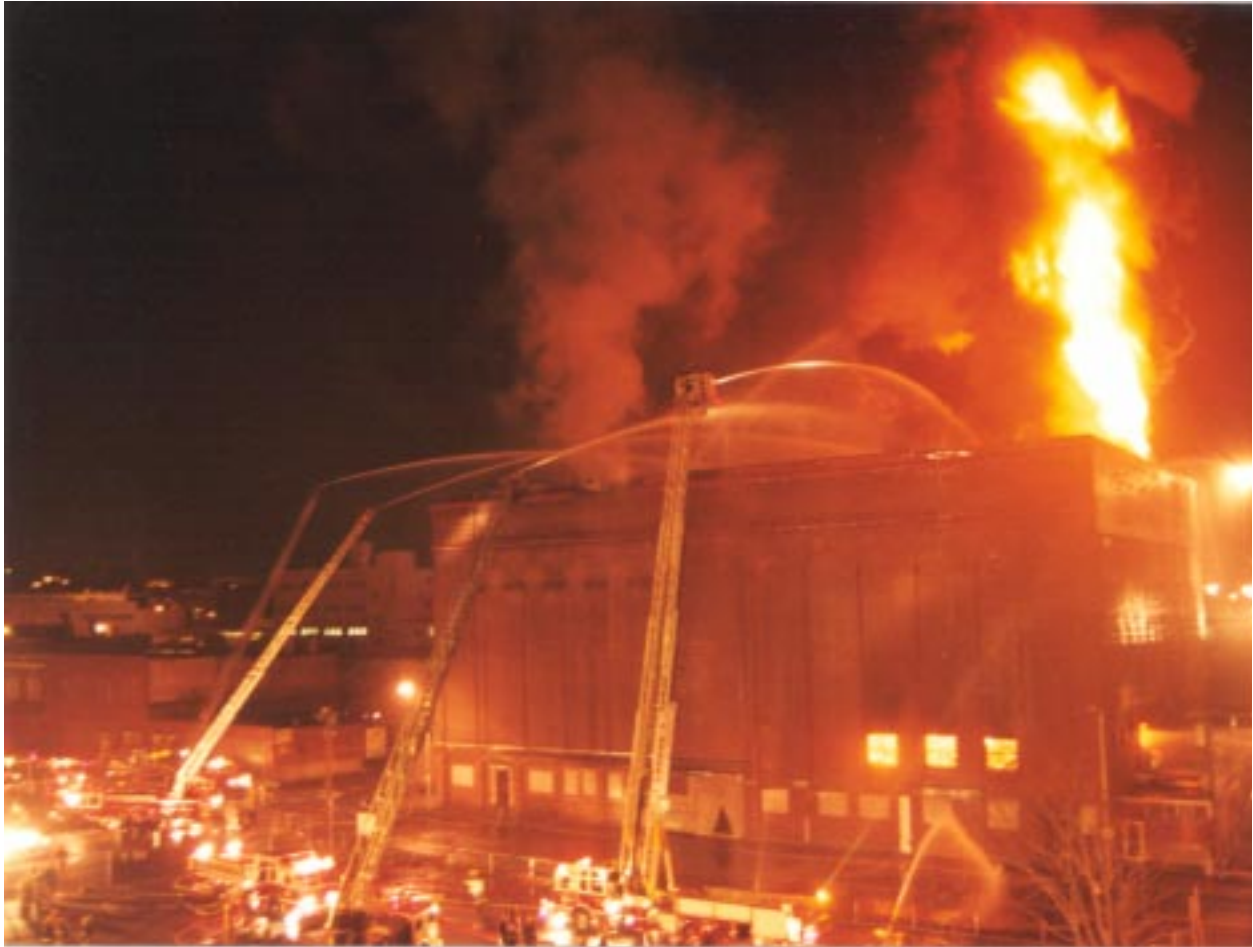
*Photo 8. Cold-Storage and Warehouse Building at 2030 Hours*
