# Metallography of the Beaded Copper Conductors

Ching-Te Huang  
Central Police University

國際縱火調查學會台灣分會  
International Association of Arson Investigators Taiwan Chapter

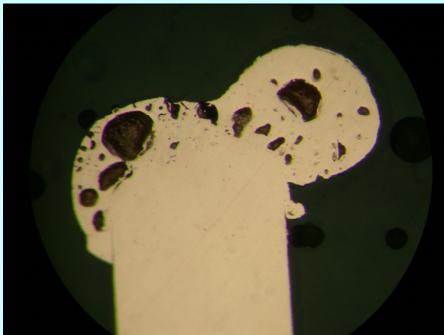
Figure 1. In extreme heat, some copper vaporizes and induces porosity within the bead. (5X)

- (1) Electric fault may have various degrees of porosity or not have any porosity.
- (2) Crystalline solids can be found in the gas porosity of electrical system failure.
- (3) Cuprous oxide can be found in the bead resulting from fire.
- (4) There are impurities in the internal part of the bead.
- (5) The grains of the undamaged copper conductor and the beaded copper have obvious distinct characteristics.

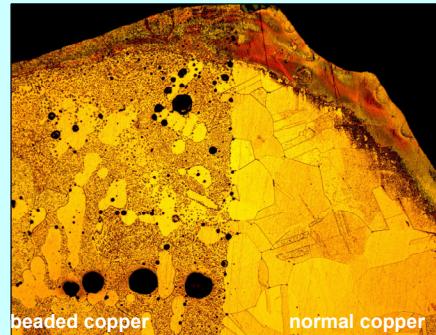
Figure 4. After etching, the grains of the copper conductor are different from the beaded copper. (100X)

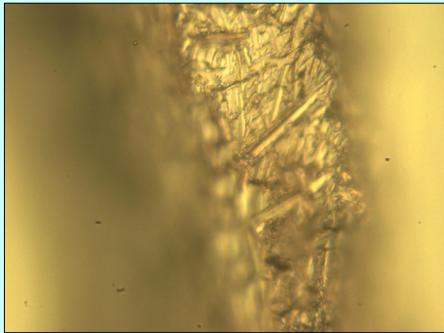
Figure 2. Crystalline solids form in the porosity of the bead. (500X)

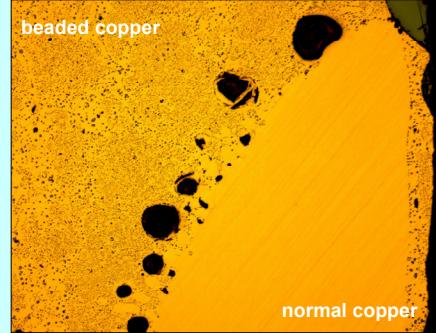
Figure 5. After polishing, there are impurities in the internal part of the bead. It is clearly different from the normal copper conductor. (100X)

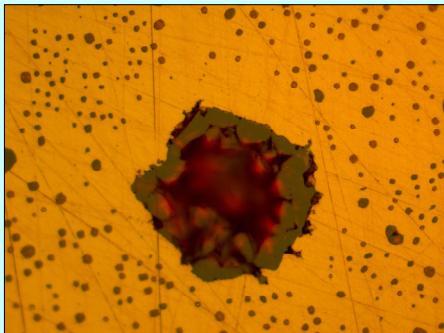
Figure 3. There is a cuprous oxide in the beaded copper. (1000X)

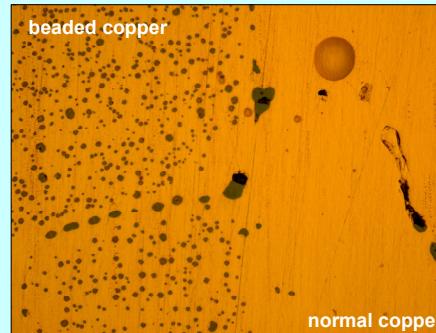
Figure 6. After polishing, there are impurities in the internal part of the bead. It is clearly different from the normal copper conductor. (500X)

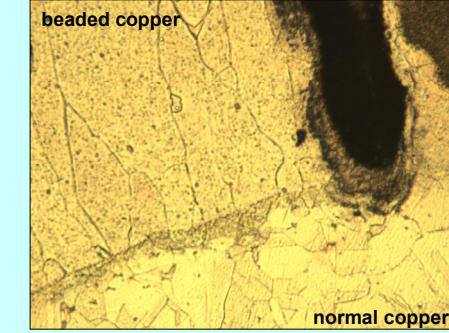
Figure 7. After etching, the grains of the copper conductor and the beaded have obvious distinct characteristics. (100X)

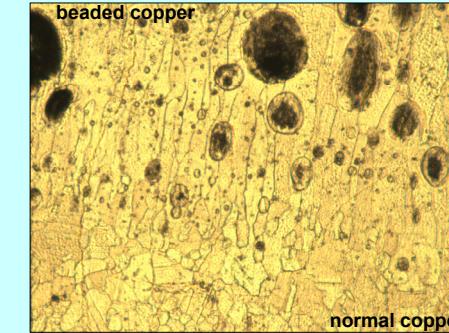
Figure 8. After etching, the beaded copper grains are columnar. (100X)
