CPSC Staff Assessment on Eutectic-Type Thermal-Cutoff Fuse Failures in Shaded-Pole Motors Used in Exhaust Fans

December 2017

Arthur Lee
U.S. Consumer Product Safety Commission
Directorate for Engineering Sciences
Division of Electrical Engineering and Fire Sciences
5 Research Place
Rockville, MD 20850

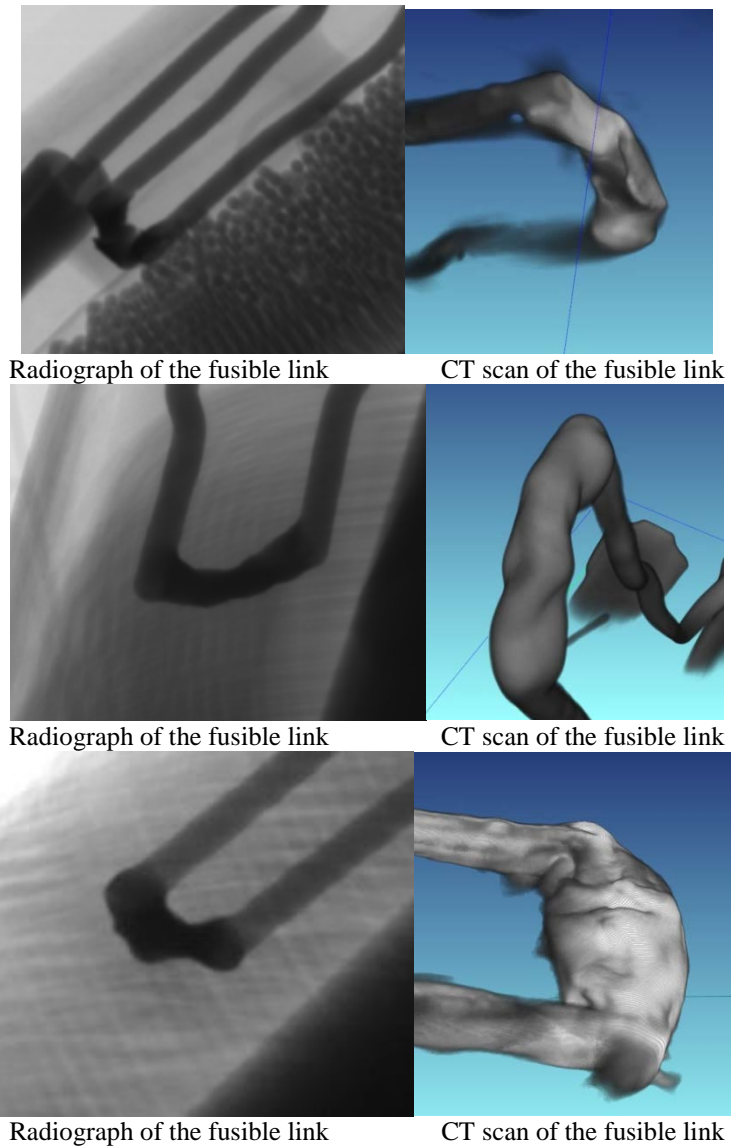
Figure 8. Fusible link with irregular thermal linkages (Sub 91, 20 and 62)

All 100 TCOs in the fans were x-rayed and 3-D imaged by computed tomography (CT). CT imaging can reveal detailed images of the internal TCO without destructive analysis. The CT scan allows cross-sectional details of the thermal linkage that cannot be seen in conventional radiographs by X-rays. The thermal linkage connects the two wire leads, as shown in the radiograph and CT images in Figure 7. In the examined thermal linkages in the fan samples, the thermal linkages varied with the shape of the linkage, such that some of the linkages were not uniform, as shown in Figure 8. It is unknown if the variations were caused from manufacturing or usage before collection.

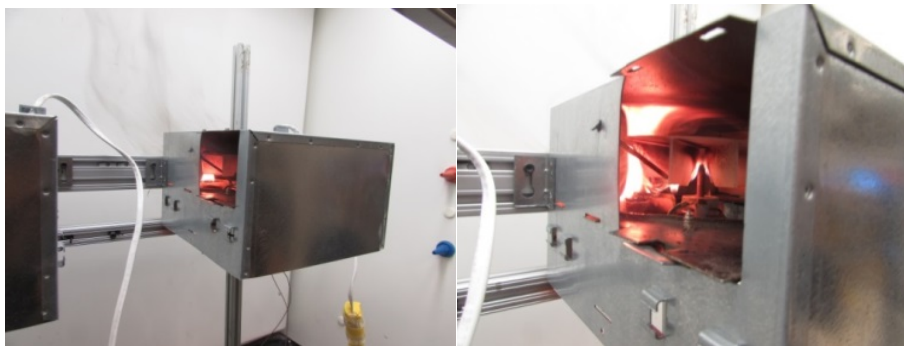
Figure 19. Bypassed TCO lock-rotor test

For the third test period, the fan was energized in the lock-rotor condition, and after about 30 minutes, the temperature increased rapidly, which resulted in smoke and flames. The thermocouple temperature traces are shown in Figure 18. The motor winding ignited, which then ignited the plastic impeller, as shown in Figure 19. The plastic impeller resulted in dripping, flaming plastic. The total lock-rotor test time was about 4.5 hours (period 1 + period 2 + period 3).

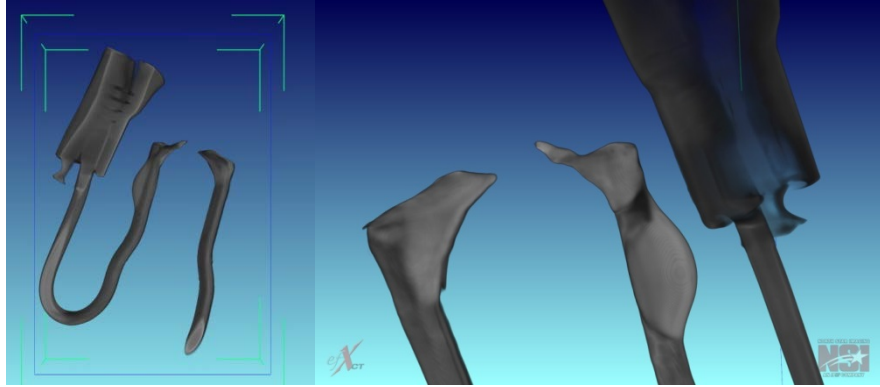
Figure 24. CT scan of the fusible link after lock-rotor testing (sub 10)

Figure 24 shows the CT scan of the fusible link after the lock-rotor test. As seen in prior testing when the trip time is longer than average, the fusible link melts at the center of the link. The figure does show a partial wetting of the electrodes occurred, which allowed the solder link to bead.

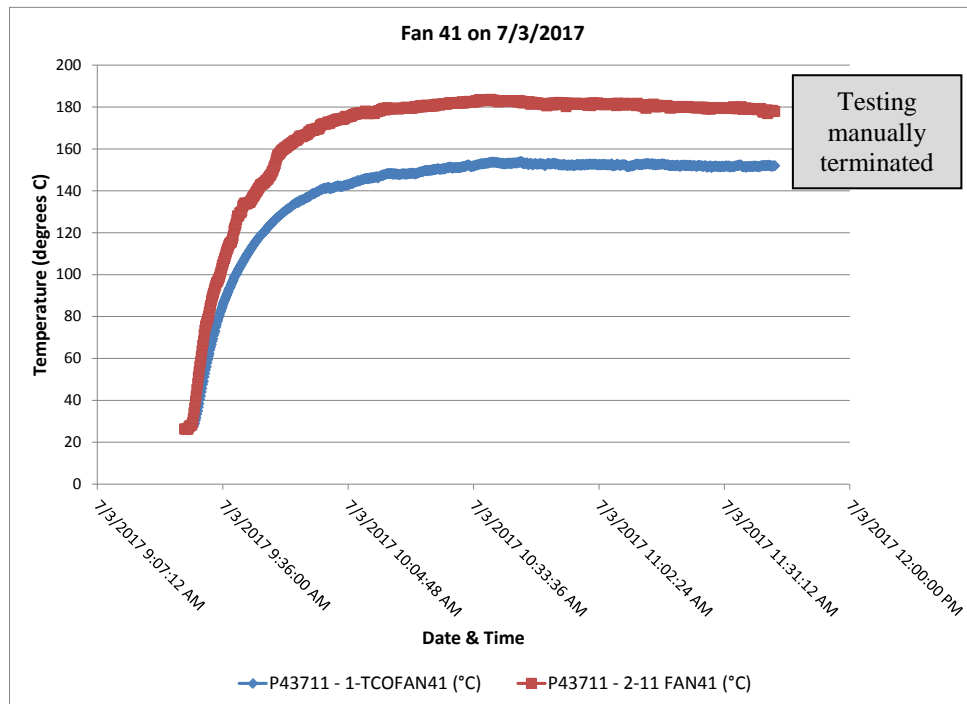
Figure 25. Temperature traces for Sub 41 Test Group 3 - Lock-rotor Test

Staff conditioned the fan (sub 41) for 232 hours 30 minutes. During the lock-rotor testing, the TCO did not activate. After about an hour, the temperature appeared to have leveled to a constant temperature or steady state. Staff terminated the lock-rotor testing after approximately 2 hours 30 minutes. Figure 25 shows the temperature traces for the thermocouples during the lock-rotor test on July 3, 2017.

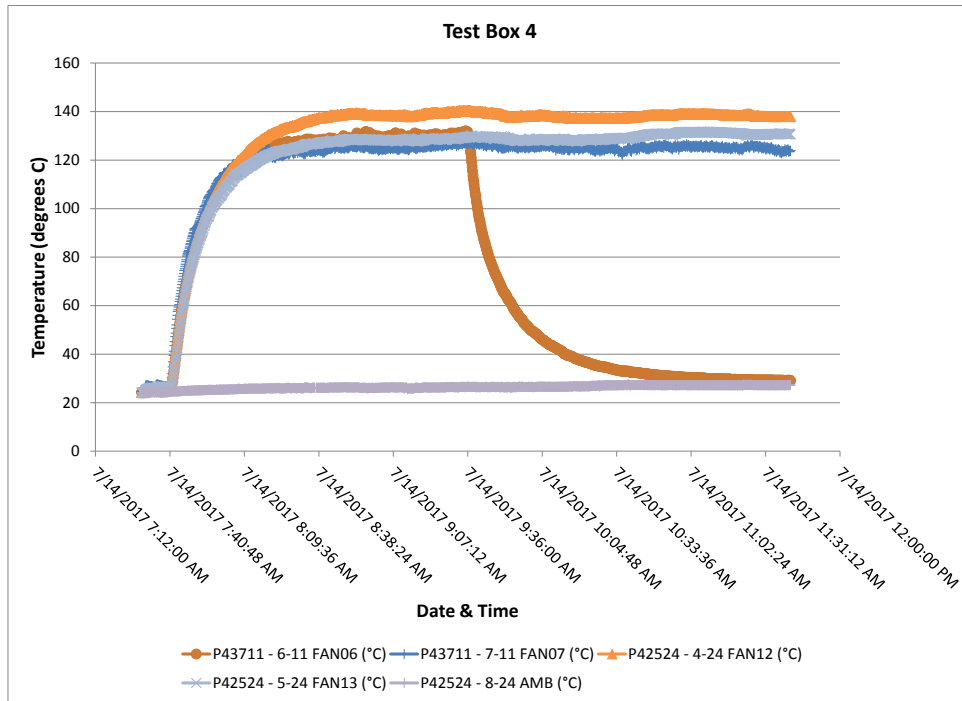
Figure 38. Temperature traces for Subs 6, 7, 12 and 13 (Test Group 4 - Lock-Rotor Test)

Figure 38 shows fan subs 6, 51, 58 and 66 temperature traces for Test Group 4 – Lock-rotor Test. These subs had a TCO that had activation trip times that were long or never tripped. The TCOs were x-rayed and CT scanned.

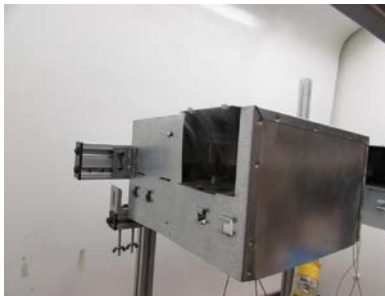
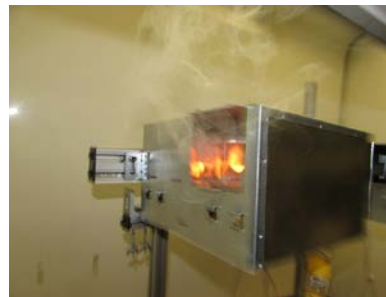
Figure 41. Fan sub 73 during lock-rotor test

Fan sub 73 was in lock-rotor condition for about 1 hour and 56 minutes before the unit ignited, as shown in Figure 40. The fan’s winding temperature was at a steady-state temperature (~188°C) above the TCO function temperature for about 1 hour, until the winding temperature began to increase rapidly. This rapid increase in temperature is an indication of shorting in the winding, which reduces the winding resistance and increases the current. Before ignition, with the winding temperature at about 233°C, the unit was producing visible white smoke. When the unit ignited around 289°C, there was a large flash and flames for a brief moment. It appears that the gaseous vapors driven off the winding coating ignited. The flames subsided slightly until the wrap around the winding and the coating on the windings started to burn, growing in intensity. The flames impinged on and ignited the plastic impeller. The burning impeller and bobbin resulted in dripping flaming plastic. Four layers of cheesecloth were placed under the fan to be used as an ignition indicator to verify that the dripping plastic continued to burn as it landed on the surface below. The dripping flaming plastic caused the cheesecloth to ignite, which indicates that the fan’s plastic grill could also ignite in this type of situation. Figure 41 shows a sequence of photographs demonstrating the progression during lock-rotor testing on sub 73.

At around 233°C, the fan begins producing white smoke

At sufficient temperatures, there appears to be an ignition of gases around the motor around 288°C

Dripping flaming plastic ignites the cheesecloth ignition indicator

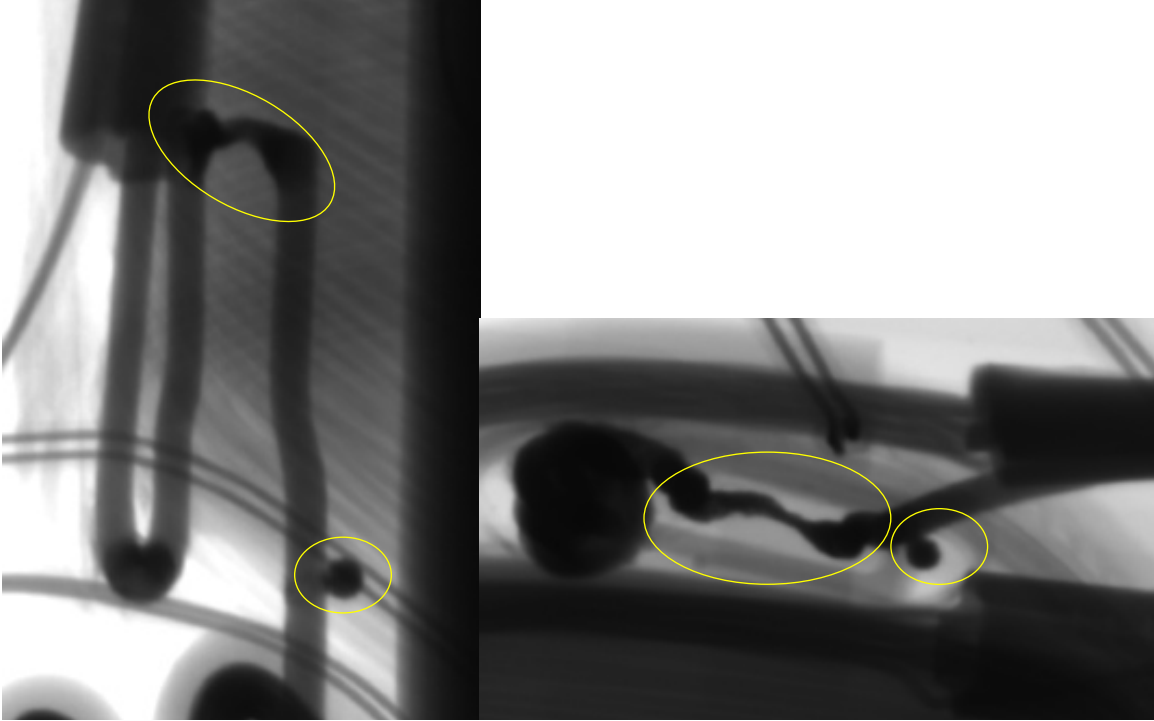
Figure 49. Radiograph of the TCO after the test (sub 54)

As previously indicated, fan sub 54 was tested in lock-rotor condition for 22 hours. After the initial 3 hours, the temperature increased and then leveled off. The fan maintained a steady temperature that was well above the TCO activation temperature for the majority of the testing, as shown in Figure 48. The TCO did not activate, and staff manually terminated the test after 22 hours. Figure 49 shows radiographs of the TCO after the test. The linkage appears to have thinned out, but is still intact. The figure shows a bead had formed outside the TCO casing.

Figure 51 shows CT scans of the TCO after the test. CT scans of the TCO confirm the solder link within the TCO is intact. The radiographs and CT scans show a solder bead has formed outside the TCO casing. This would suggest that the TCO is no longer hermetically sealed when thermally aged or placed under thermal stress. The reason that the windings were operating at such an elevated temperature for so long without eventually breaking down is not known, but it can be surmised that the winding coating would eventually deteriorate and cause shorts within the winding because the eutectic temperature has changed from T_f .

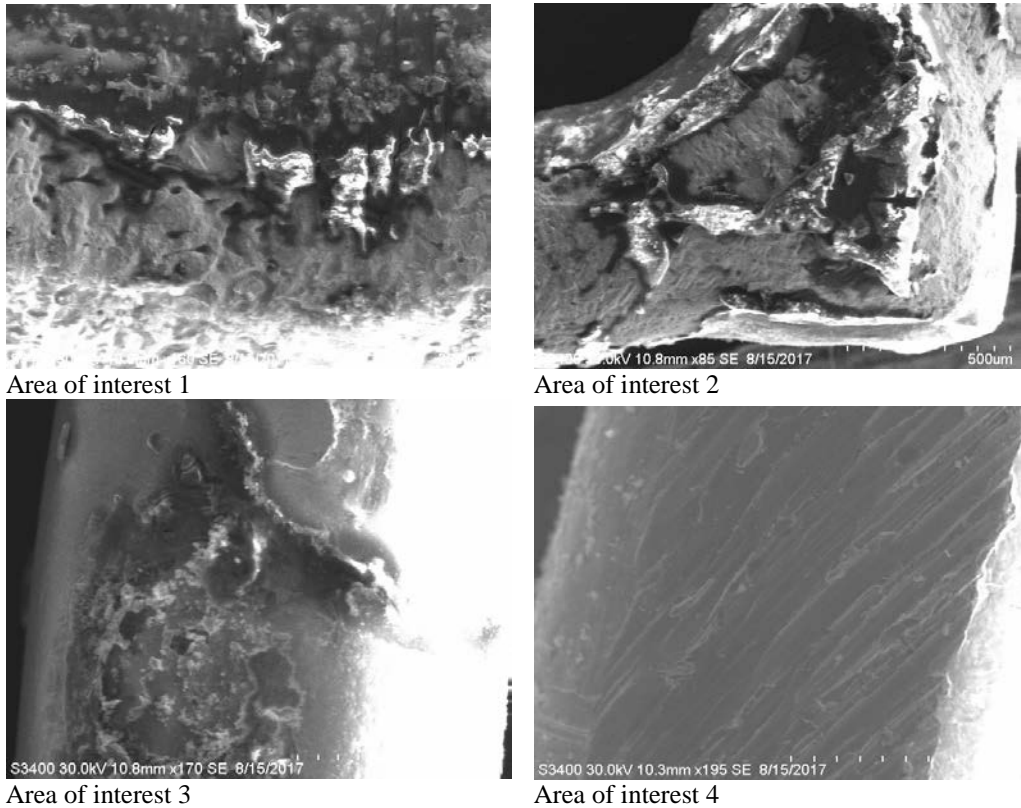
Figure 56. SEM scans for Sub 59

characterization. XRD is used to study nature of phases/microstructure and their crystal structure. Figure 56 shows SEM scans of the solder link and terminals. SEM and XRD analysis for sub 59, which was conditioned at 105°C, show that the wire leads are copper and the thermal linkage is comprised of mainly tin, indium, and lead.

Area of interest 2 is the solder link connection to the copper terminal. This is mainly comprised of C, O, In, Sn and Pb. There is a trace amount of silicon (Si) and copper (Cu). Copper shows up because it is the bulk material of the terminal.

Areas of interest 3 and 4 are the copper terminals. This is mainly comprised of Cu and Sn. There are lower amounts of C and O.

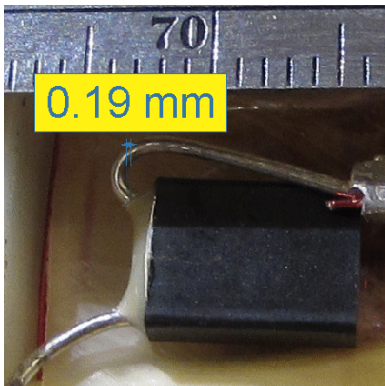
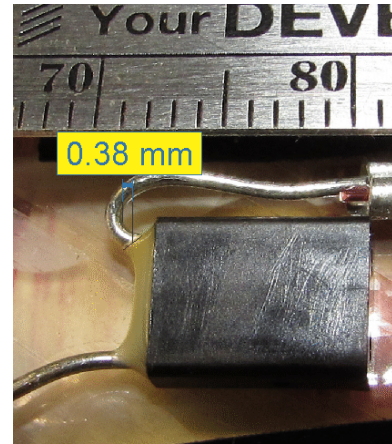
Figure 58. Wire bend lengths vary between TCOs in the Fan samples

Staff conducted research to determine whether there is standard practice for bending the lead wires on TCOs. Below is a list of precautions in bending the wire leads. The general practice appears that the bend should occur 3 to 4 mm from the seal. It is also recommended that the wire lead is held during the bending to prevent stress on the seal, which may cause the seal to leak. Lock-rotor testing has shown that solder from the thermal linkage can seep out of the seal, forming a solder bead on the wire lead outside the casing. This would suggest that a crack has formed between the seal on the wire lead.

Figure 58 shows the TCO wire lead bends can vary between fan motors. Even though sub 27 shows the wire lead bend greater than 3 mm, it appears that the base of the wire lead near the seal was not secured when the wire lead was bent, which is evident by the outward angle of the wire lead.

Wire lead with 0.19 mm length between the seal and bend (Sub 98)

Wire lead with 0.25 mm length between the seal and bend (Sub 26)

Wire lead with 4.52 mm length between the seal and bend (Sub 27)

Wire lead with 0.38 mm length between the seal and bend (Sub 79)

- Lead wires (terminals) are to be bent or cut at least 3mm away from the TCO seals to avoid damaging the TCO (axial/radial type) or body (thin type). The TCO seals (axial/radial type) shall not be grasped with any tools or holders. Terminals of thin type TCO are to be grasped before they are bent. (See Fig. 1) (Reference - XICON PASSIVE COMPONENTS, Thermal Cutoffs (TCO)/Thermal-Links 447-XYP 1BF145-RC).

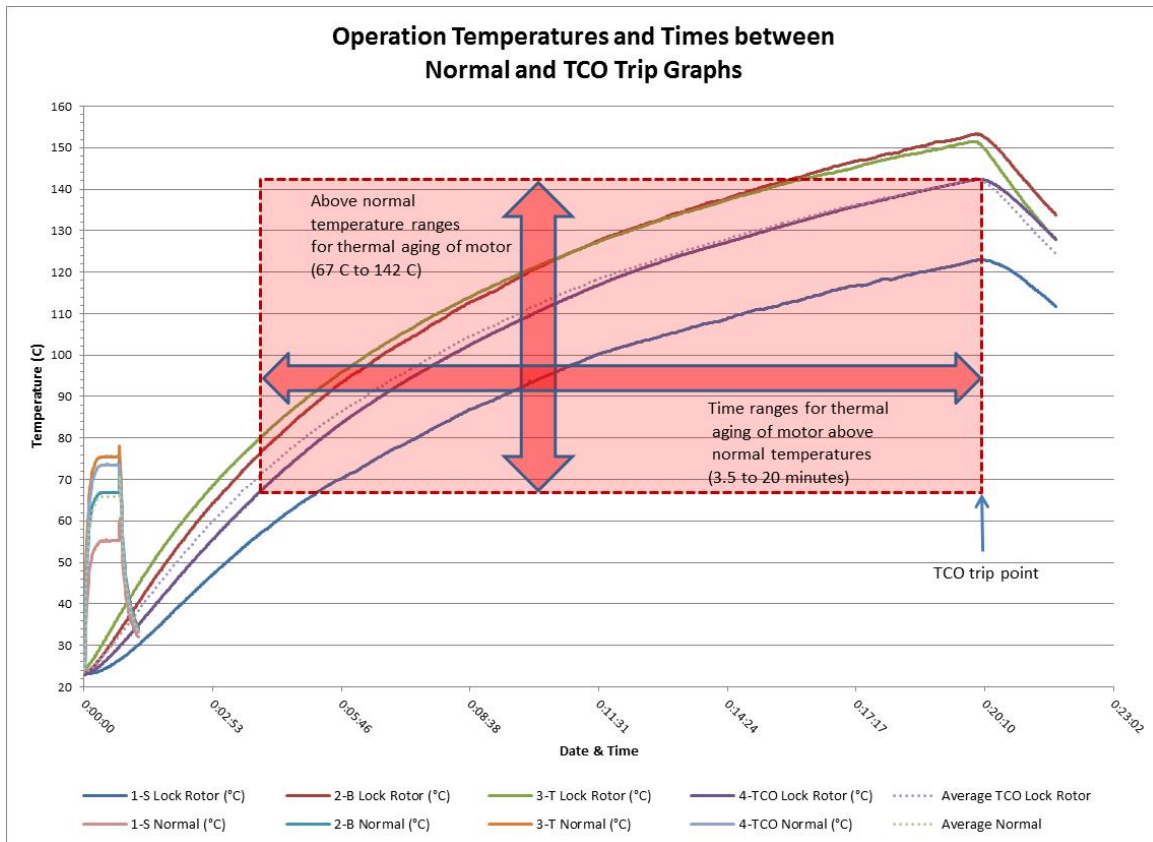
Figure 59. Potential thermal aging of the motor between normal and TCO trip conditions

Figure 59 shows Fan sub 60 temperatures for normal and lock-rotor operation. In normal operations, the TCO temperature stabilizes at around 68°C. For lock-rotor condition, the TCO activates at a TCO temperature around 142°C after 20 minutes. This would suggest that an exhaust fan that is in lock-rotor condition, but is operated for less than 20 minutes, can have the TCO heated to temperatures up to 142°C. If the exhaust fan is operated for more than 3 minutes, the TCO is experiencing temperatures above normal operation.
